APSHAWA MAIN DAM

APSHAWA AUXILIARY DAM

PHASE I INSPECTION REPORT

NATIONAL DAM SAFETY PROGRAM

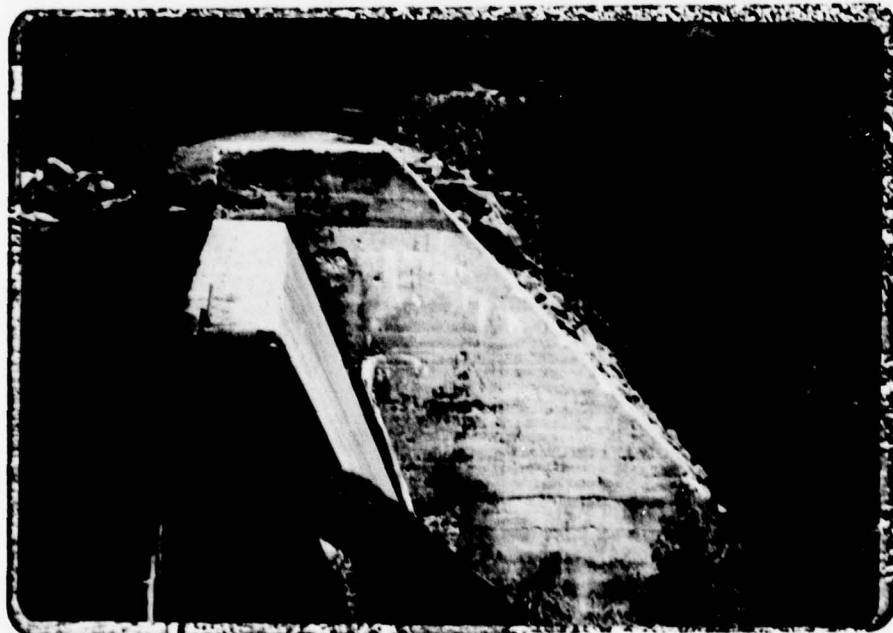
The spillway and side walls appear to be the most sensitive part of the whole retaining structure. The concrete has spalled and has fine cracks.

Spillway side wall looking east. 19 June 1978  
Note spalling of concrete and  
downstream riprap.

2. Deterioration of the spillway concrete should be repaired and measures taken to minimize further concrete deterioration. This should be done in the future.

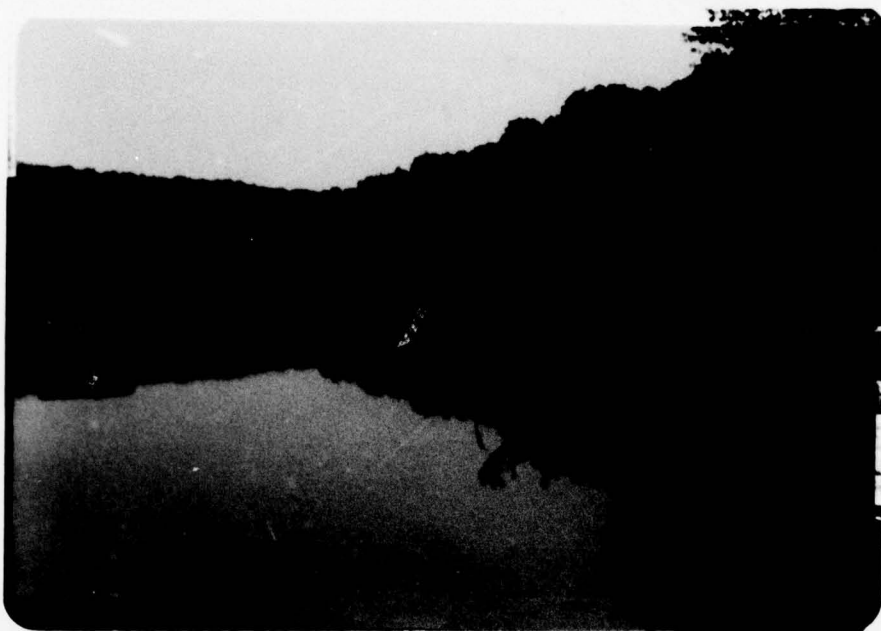
Outlet gate house and  
left side of spillway.

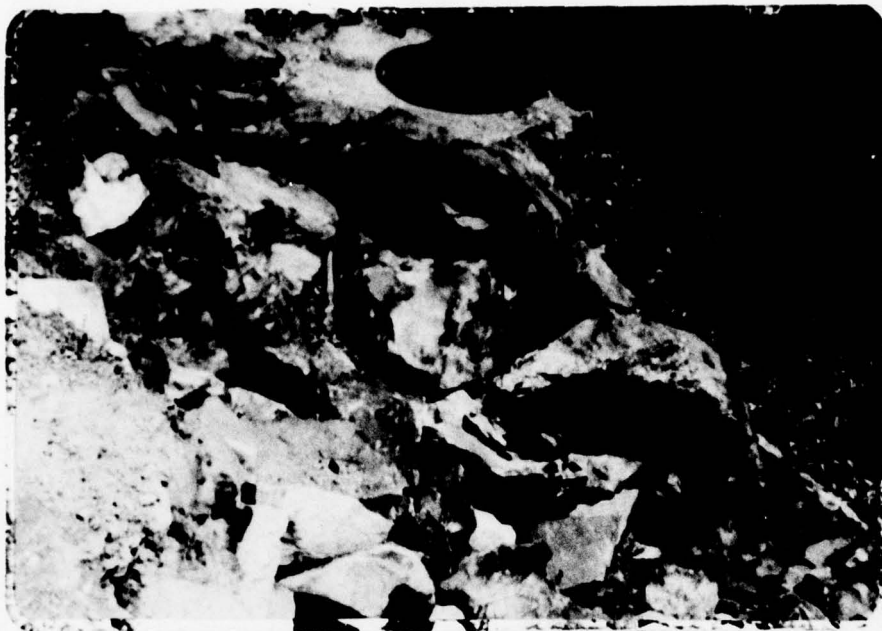
Downstream outlet gate house      19 June 1978  
at left embankment.

4. An investigation should be made to determine if there are obstructions at the intake tower gate. The downstream gate house should be cleaned out and the outlet valve maintained. The degree of corrosion of the 14-in-dia. outlet pipe should be checked. This should be done very soon.

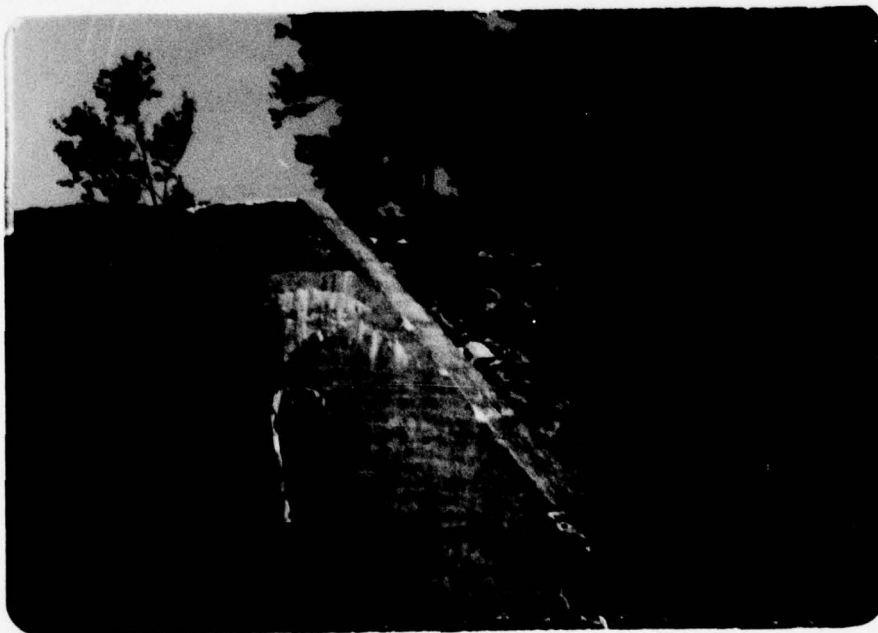
Spillway left sidewall.  
Note disturbance of riprap.

3. The rip-rap and the top of the main dam near the left side wall of the spillway and upstream rip-rap should be repaired. This will require replacement of missing rip-rap and should be done very soon.

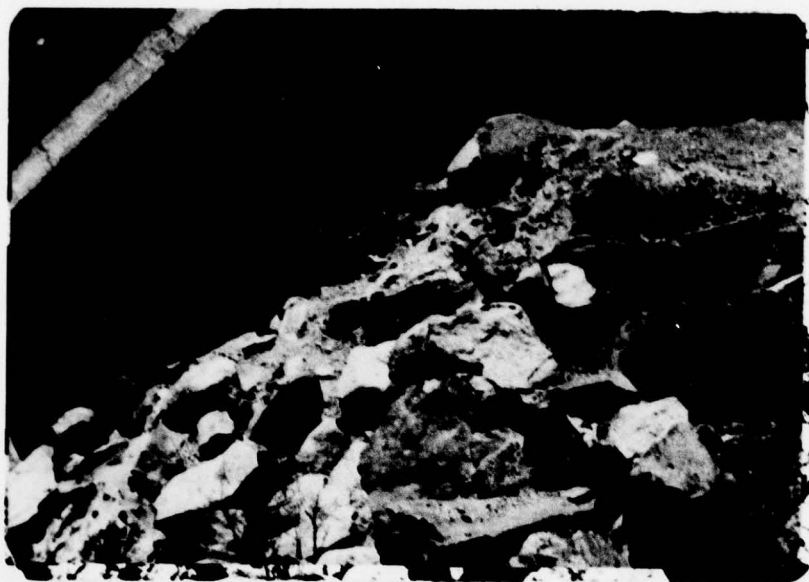
No signs of movement or settlement were observed on the embankments except on the section near the left spillway side wall. In this area, and for a length of a few feet, there are traces of erosion and possibly overtopping. This erosion goes down approximately three feet below the crest and the downstream face of the upper part of the rock fill has fallen down. It does not appear likely that this damage was caused entirely by overtopping and may be a consequence of vandalism or a lack of maintenance. The damage may have been increased by erosion and overtopping.

Erosion and removal of riprap      19 June 1978  
at spillway and left sidewall  
abutment.

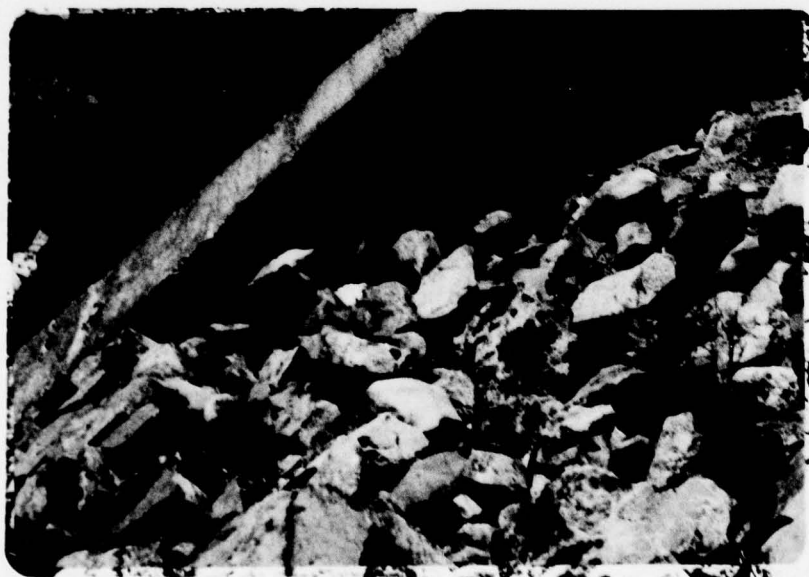
Erosion of riprap at spillway      19 June 1978  
and left sidewall abutment.

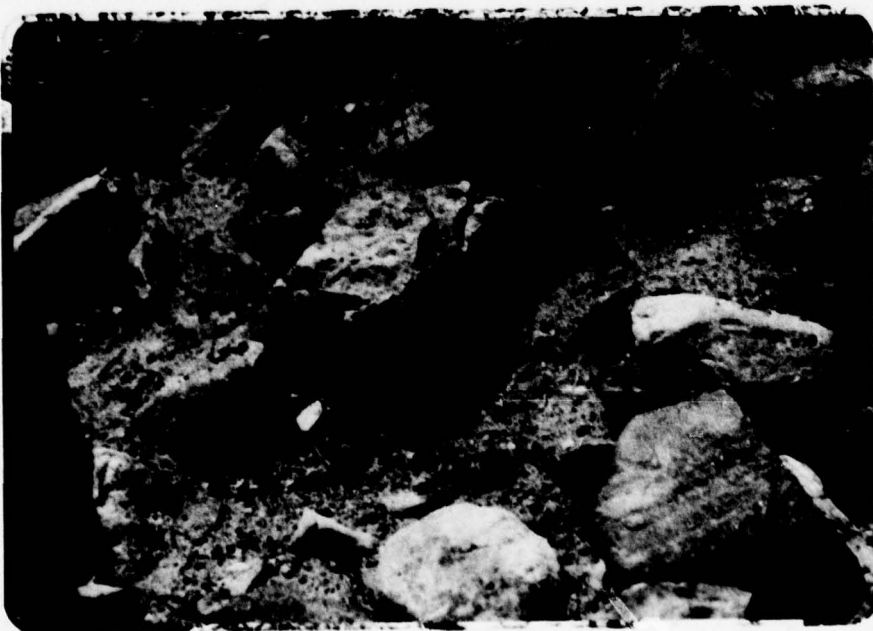
Erosion of riprap and earth at  
left spillway sidewall abutment.

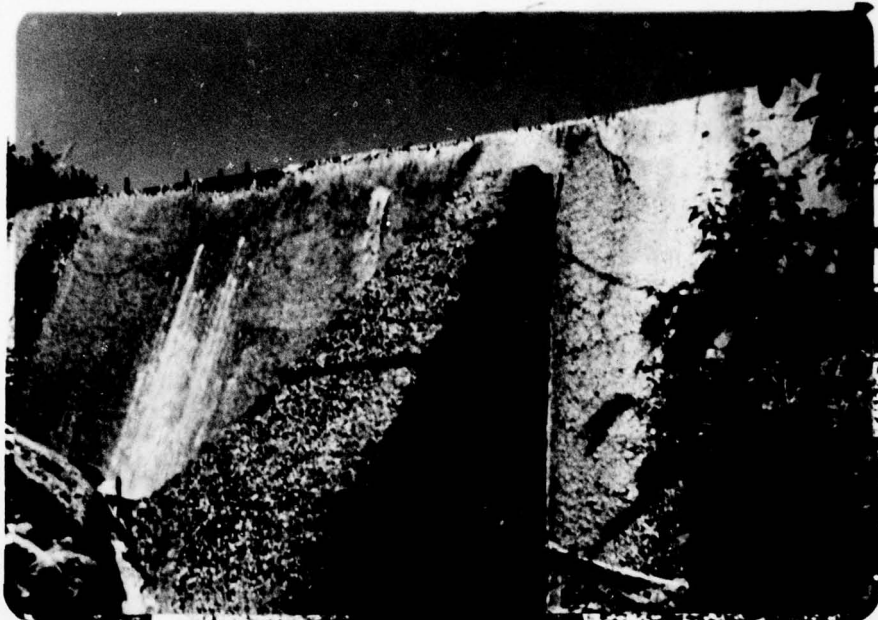
Central buttress pier at  
downstream face of spillway.

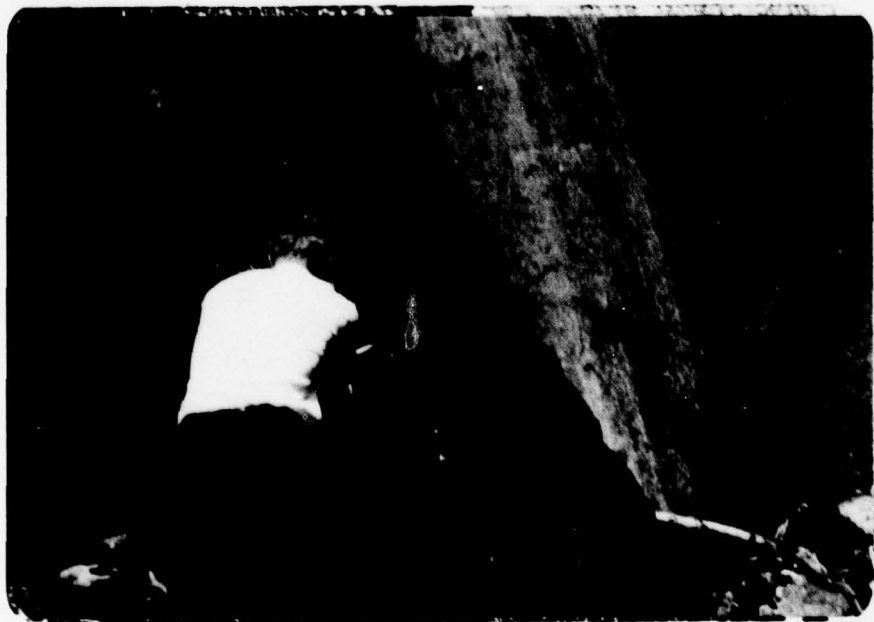
Central pier at spillway.  
Note horizontal grooves where  
concrete lifts were placed.

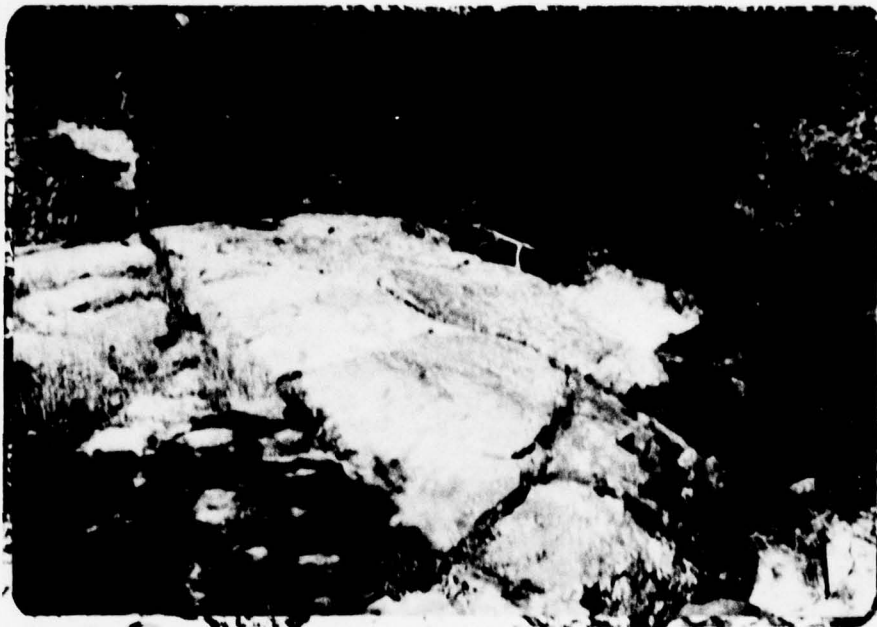
Foundation rock at base of  
central pier at downstream  
face of spillway.

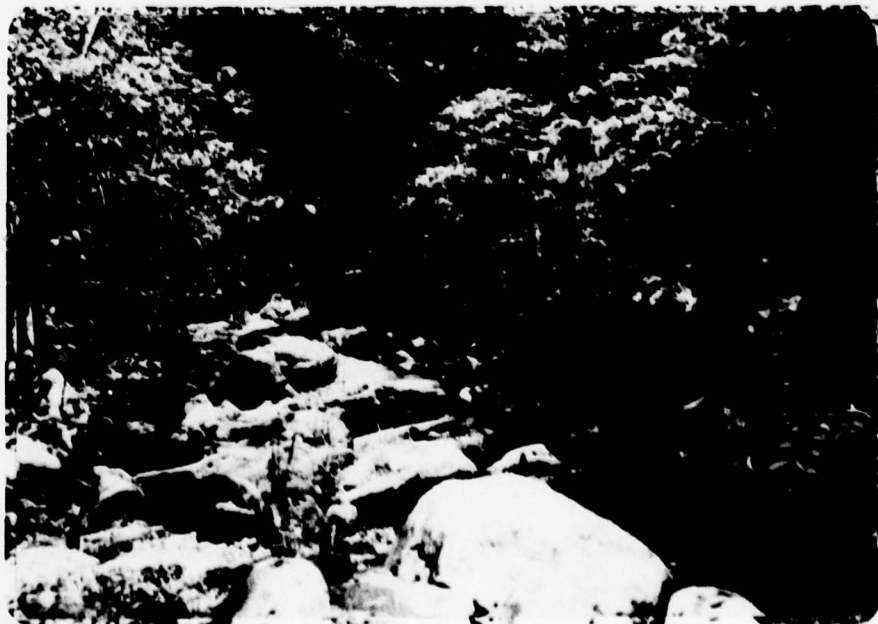
Spillway discharge channel  
looking downstream.
